# Lead Drops Keep Falling in the Air

The abbey Church of Sorø and the use of lead on roofs in 12<sup>th</sup> century Denmark

PER KRISTIAN MADSEN, THOMAS BERTELSEN, ARNE JOUTTIJÄRVI & KARL-MAGNUS MELIN

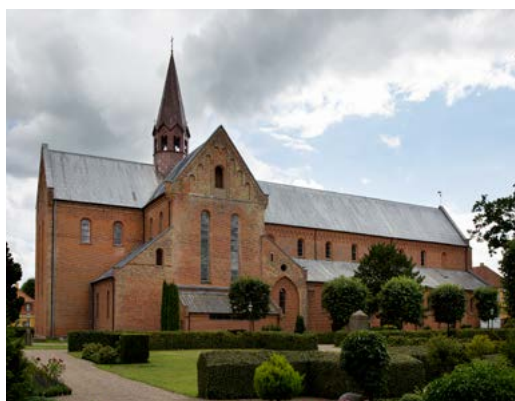
Fig. 1. Abbey church of Sorø, north side. Photo: Thomas Olsen 2020.

Soon after having advanced to the episcopate of the diocese of Roskilde in 1158, the new bishop Absalon (Roskilde 1158-1192, archbishop of Lund 1178-1201) reformed his family monastery of Sorø, Central Zealand (fig.1). From being a traditional Benedictine Monastery, it was changed into an abbey of the new and prosperous Order of the Cistercians. The white monks were to carry on the commemoration of the founding magnate family, which was later given the popular name Hvide. Members of this powerful clan had close contacts to the Danish kings Valdemar the Great (1157-1182) and his two sons, who followed him successively on the Danish

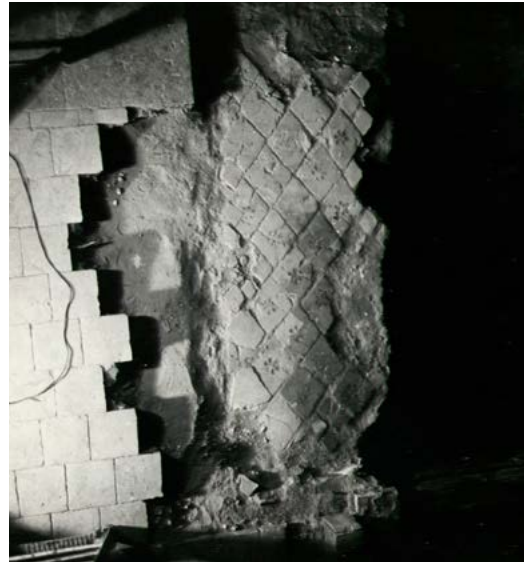
Fig. 4. A small part of the oldest floor of glazed tiles from the abbey Church of Sorø, found in situ in front of the steps into the main chancel. The tiles show traces of fire from burning roof beams which had fallen from the roof. Photo: H. Stiesdal 1970, the National Museum.

also covered with lead (Høyen 1869, 68). If so, drops of lead may have hit the upper surface of a wooden ceiling inside the church in order to proceed from there to the floor where the metal could be recovered. In fact, traces of burning wooden beams have been recorded on the first tile floor just in front of the steps into the chancel (Hansen & Sørensen 2005, 211) (fig. 4).

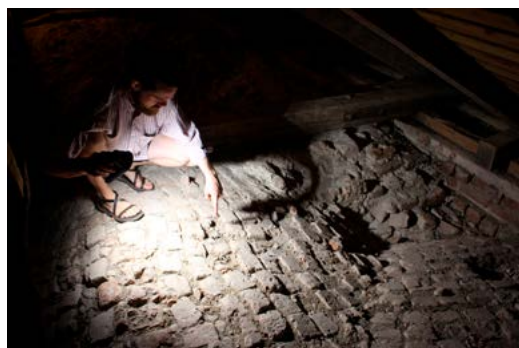
Fig. 5. The area on top of the vaults in the eastern end of the northern aisle where lead drops were discovered and later removed. Photo: Thomas Bertelsen 2018.

very sparse remains of the peculiar lead forms were still left in their original positions. Almost all lead had been removed from the top surface of the vaults, leaving only some few remains (fig. 5). In the archives and collections of the Academy of Sorø and the National Museum no records about the removal of the lead or its whereabouts could be found.

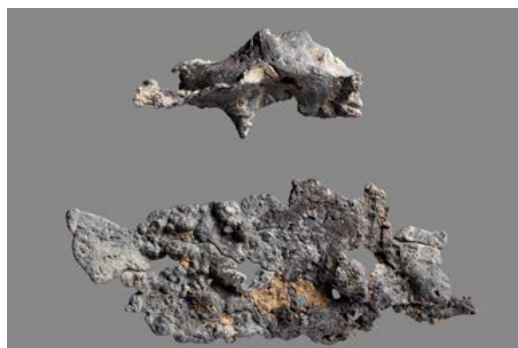
Fig. 6. Lead drops from Sorø found in a storage container with fragments from the lead coffin of archbishop Absalon. Photo: Arnold Mikkelsen 2018, the National Museum.

This situation changed later that same year when a row of containers with tens of thousands of pieces of pottery was emptied at one of the National Museum's storage facilities. One of them contained the missing lead stalagmites from Sorø, which were immediately recognized by the museum curator also involved in the restoration of Sorø. No proper indication of the origin of the lead was kept but indirectly some undated pages from a local newspaper "Sorø Amtstidende" and a couple of bricks with the large distinctively painted numbers from the Collections of the Academy of Sorø gave a further hint to the provenance. So did also a piece of paper with the name "Absalon" written on it which accompanied some quite differently looking fragments of lead sheets in their own separate box (fig. 6).

The rediscovered pieces of lead from the vaults in Sorø and from Absalon's coffin were all subject to a scientific analysis by the Heimdal-Archaeometry Laboratory. Five samples were taken from the molten roof lead drops and three from the coffin. A metallurgic analysis showed that the two sets of lead differed from each other in the composition of impurities, most likely because the lead must have been brought in from two different geographical production areas. By comparing the content of lead isotopes in the samples with lead from a series of European lead producing districts it was found that the lead from the roof in Sorø originated from north-western Germany, more precisely the area around the cities of Aachen and Cologne. On the other hand, the lead from archbishop Absalon's coffin came from southern England (Jouttijärvi 2020).

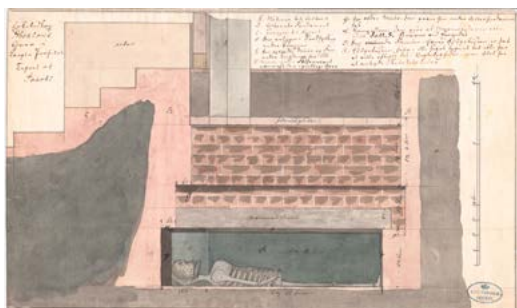
Fig. 7. The grave of Absalon, plan and drawings from excavation in 1827. Including his funerary chalice and paten and his finger ring as a bishop. Drawings and/or recent photos. In Antikvarisk-Topografisk Arkiv, the National Museum.

the National Museum who was known for his love of the abbey and the Academy of Sorø. In 1947 he participated in the last opening of the grave of archbishop Absalon under the guidance of the National Museum. Absalon died the 21<sup>st</sup> of March 1201 in Sorø and was laid to rest in a lead coffin in front of the main altar in the chancel. According to church habit he was buried in his magnificent shroud as an archbishop (Krag 2024). The first known opening of his grave took place in 1536, the year of the Lutheran Reformation. King Christian 3 was present and in the company of the first Lutheran bishop of Zealand, maybe in an attempt to demonstrate some kind of succession. In 1827, the grave was opened again in order to investigate the authenticity of the so-called "Absalon's skull" in the Royal Kunstkammer (DK Sorø 1936-1938, 79f). Fragments of Absalon's liturgical vestments, his finger ring, the funerary chalice and paten as well as a lead plate with an inscription to his commemoration were all taken out (Malling et al. 1836). These items are today on public display in the church (Mackeprang 1921; Krag 2024) (fig. 7).

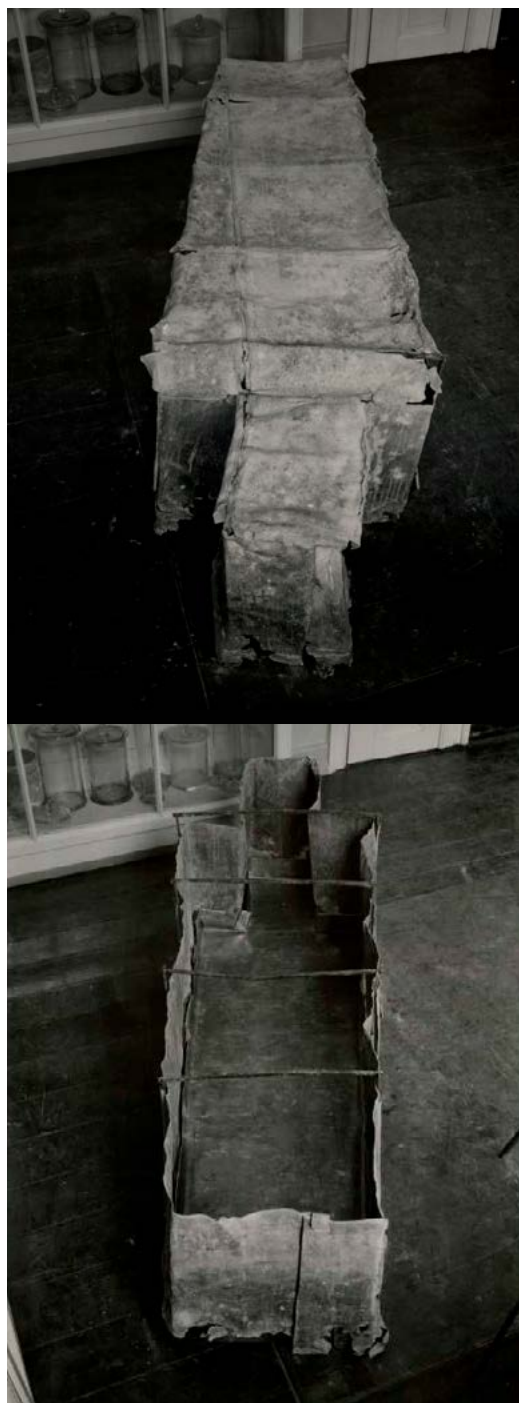
Fig. 8. The lead coffin of archbishop Absalon during its temporary stay in 1948 in the National Museum's workshop in central Copenhagen. With and without lid. Photo: Niels Elswing 1948, the National Museum.

some photos. Some of them were taken in 1948 when the lead coffin with its lid, and presumably the dead archbishop, had been removed to the National Museum in Copenhagen for examination or restoration (fig. 8). The bones, the funeral equipment and the garments of Absalon must have been taken care of and separated from each other while the bottom of the coffin was removed. That a quite considerable part of the coffin was still kept in the museum remained unknown until the rediscovery in the storage container in 2018. The relocated lead fragments seem to be a part of the bottom or maybe the lid at the head end, which was specially designed for the dead archbishop's head with his tall mitre.

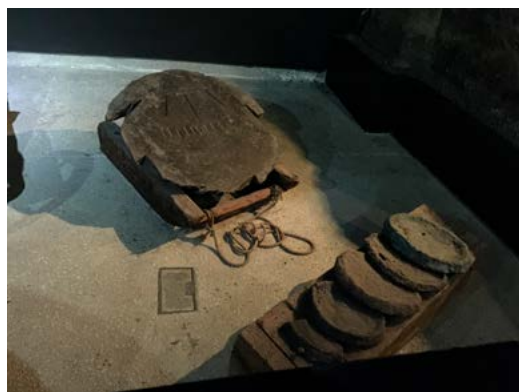
Fig. 10. A lead ingot of 693 kilos, from Krakow. Photo: Per Kristian Madsen 2015.

Lead ingots of this heavy kind may, similarly to the Gotlandic baptismal sandstone fonts, have been exported by sea into Western Europe or across the Baltic Sea for Denmark and other Nordic regions. Any such traffic required not only ships for transport, but also wagons, oxen, and men. In the 12<sup>th</sup> and 13<sup>th</sup> century, quite a number of loaded ox wagons must have brought lead for the abbey Church roof in Sorø from some port of discharge, maybe on the western shore of Zealand towards the Great Belt. Viking Age/early medieval wagons could carry about 500 kilos although there might have been wagons built for heavier loads (Schovsbo 1987, 142). Church accounts from western Zealand from the second part of the 16<sup>th</sup> century indicate that a peasant's wagon could only carry one hundred bricks counting a total weight of some 500 kilos. Another source, however, mentions that in 1584 even loads of 500 bricks weighing some 2.500 kilos were carried by special wagons (Troels-Lund 1879 (1968), 163 f).

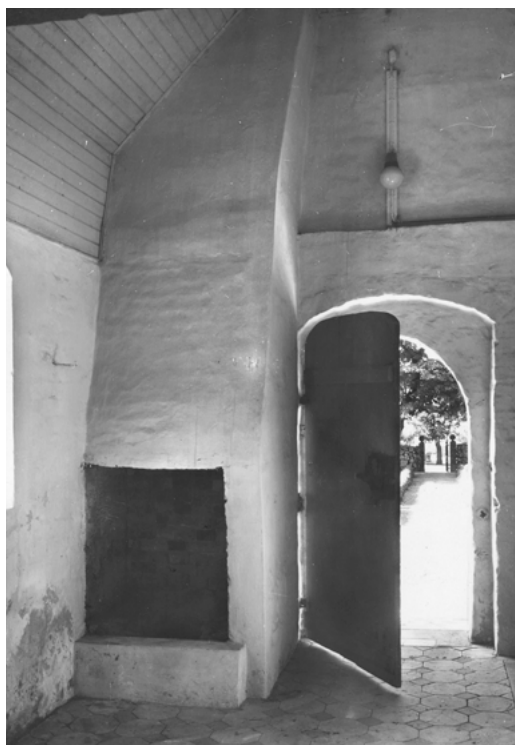
Fig. 12. A fireplace built with bricks in the porch of the church in Sdr. Hygum in southern Jutland. Pieces of molten lead have been found in it. Photo: Elna Møller 1952, the National Museum.

From the Late Middle Ages lead melting is known to have taken place in fireplaces which were built from stone inside the church porches in quite a few Danish churches (Bertelsen 1998) (fig. 12). The Scanian lead furnaces in the post-Reformation era are often mentioned as "*gruva*", which indicates a structure with a pit or cavity. Generally, the cost for materials (basically clay of proper quality) for a "*gruva*" was recorded as an expense with every reroofing with lead sheets. The reuse of furnaces in parish churches is a possibility but has so far only been found once in the written accounts from the diocese of Lund, when the roof at Bjäresjö church was repaired in 1768 it was stated that "*The furnace (gruva) was ruined and has been repaired*" (Karlsson & Melin 2022). For big enterprises like cathedrals and abbey churches it would probably be very impractical to use

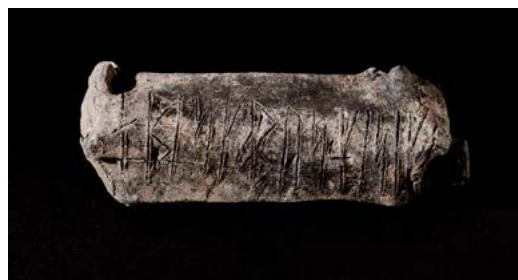
Fig. 13. The lead reliquary from Stokkemærke Church with its runic inscription. It reads in Latin: “Bishop Gisiko” (1286 – 1300). Photo: Roberto Fortuna 2018, the National Museum.

can be dated by dendrochronology (Melin 2022). Dating is essential here and the same is true for lead amulets with their inscriptions (Imer & Stemmann-Petersen 2016), as well as the lead inclusions in altar sepulchres and their small lead boxes with relics which may often have come from rather far away (cf. Karlsson 2015, 67ff). Analysing such samples within a dating frame may perhaps show a pattern of origin, trade and use of lead amulets and reliquaries. One fine example to include would certainly be the lead reliquary from Stokkemærke church on Lolland (DK Maribo 1948-1951, 458; Moltke 1976, 360) (fig. 13). It still shows its runic inscription from a reconsecration of the altar, telling the name of the bishop in charge, who held his seat between 1286 – 1300. Perhaps the lead came from across the Baltic Sea.

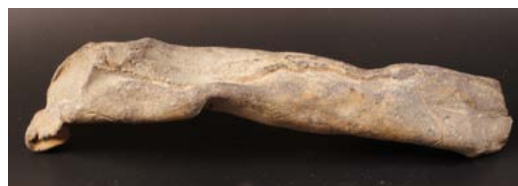
Fig. 14. Possible water pipes of lead from the abbey of St. Thomas and the Paraclete in Æbelholt, northern Zealand. Photo: Kjartan Langsted 2022, Museum Nordsjælland.

Another quite interesting subject are the possible lead pipes for water from the abbey of St. Thomas and the Paraclete in Æbelholt, northern Zealand (fig. 14). In one of his letters Abbot Vilhelm referred to the difficulties with the water pipes during the construction of his new institution (DD/DRB, 1. Rk., vol 3, Abbed Vilhelms Breve no. II,35; DK, Frederiksborg Amt, 1964-1975, 1435, annotation no. 49 and 40). Unfortunately, he did not mention the material of these pipes as other pipes made from clay have been found at Æbelholt as well. No matter whether the lead fragments really represent lead pipes or simply folded pieces, analysis may be able to show from where the Parisian Vilhelm got his lead.
